Report on the green roof monitoring in Benaguasil

E²STORMED PROJECT
Improvement of energy efficiency in the
water cycle by the use of innovative
storm water management in smart
Mediterranean cities
www.e2stormed.eu

Date: 30th June, 2015

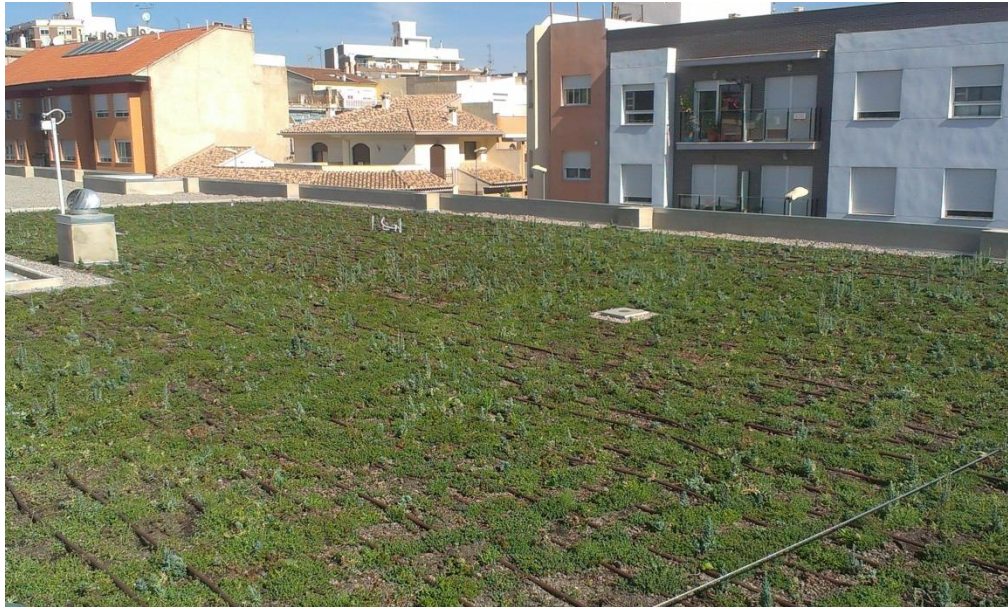
Figure 1.1. General view of the green roof in Benaguasil.

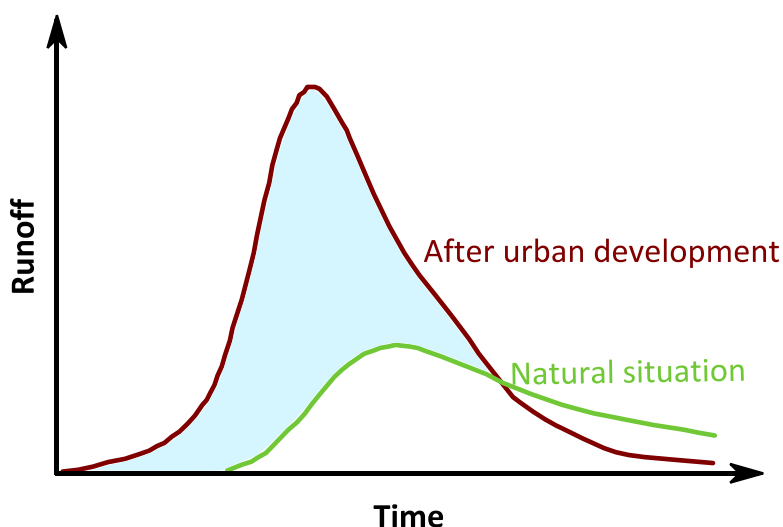
Urban development produces higher and more rapid peak discharge, with higher runoff volume and a more rapid return to low flows (Figure 1.3). The alteration of natural flow patterns may lead to flooding and channel erosion downstream of the development. Moreover, the decrease in percolation into the soil can lead to low baseflows in watercourses and reduced aquifer recharge (Woods-Ballard *et al.*, 2007).

Figure 1.3. Runoff production in natural situation and after urban development.

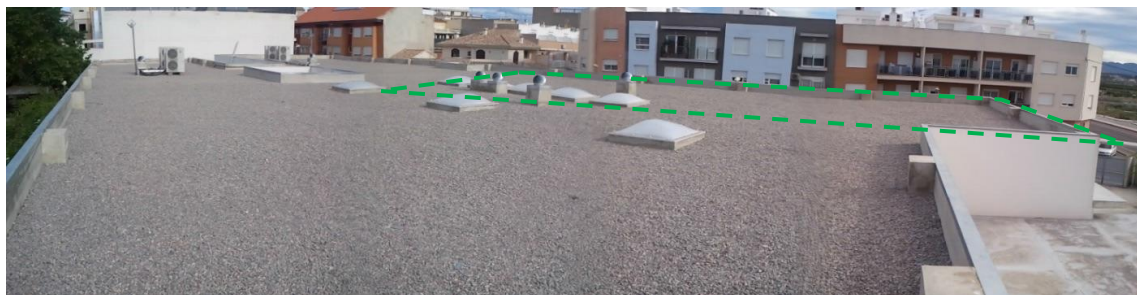
Figure 2.3. General view of building roof (green dotted line indicating green roof affected area).

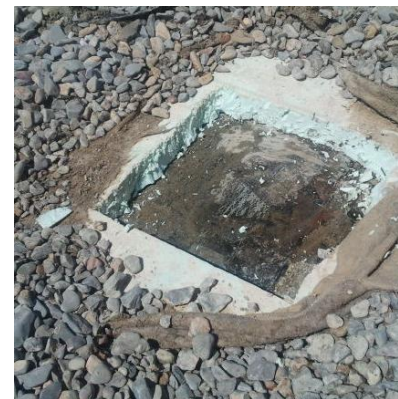
The building has a flat roof. It has “inverted roof” typology which is characterised by having the thermal insulation (XPS) over the waterproofing membrane. Over the thermal insulation usually lays a geotextile filter and a gravel layer.

Figure 2.4. Constructive layers of conventional “inverted roof” (initial situation).

The roof of “Centre de Dia” building has exactly the same layers of the picture above. These are the layers and their widths:

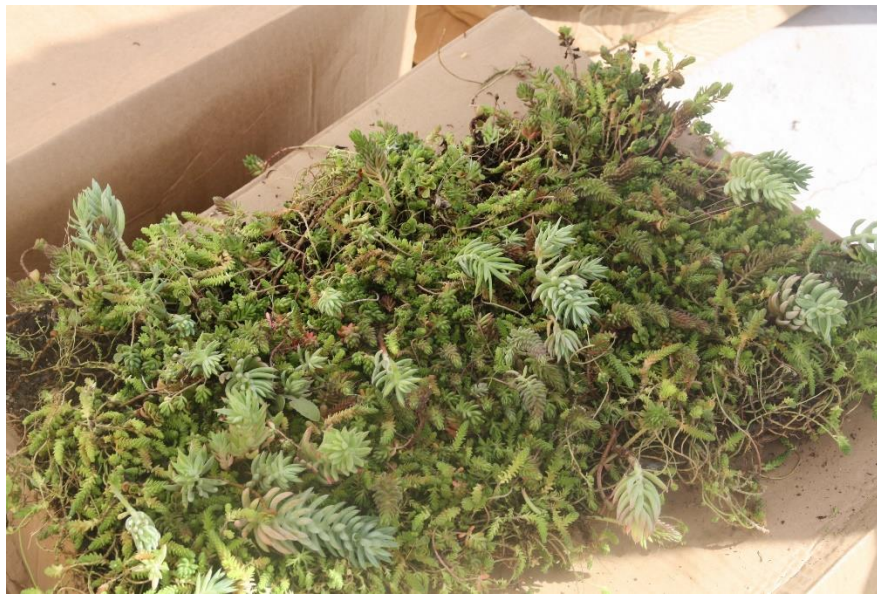
In the upper part of the green roof there are plants covering about 80-100% of its area with a height in the range 5 – 15 cm (see Figure 2.6). The plants are genus sedum (a mixture of sedum album AH, sedum floriferum AH, sedum sediforme AH, sedum reflexum AH, sedum spurium AH, sedum moranense AH, sedum acre AH).

The growth medium is a mixture of conventions gardening organic substrate (40%), volcanic lava rocks (40%) and silica sand (20%).

Figure 2.6. Vegetation, genus Sedum, used for the green roof (February 2014).

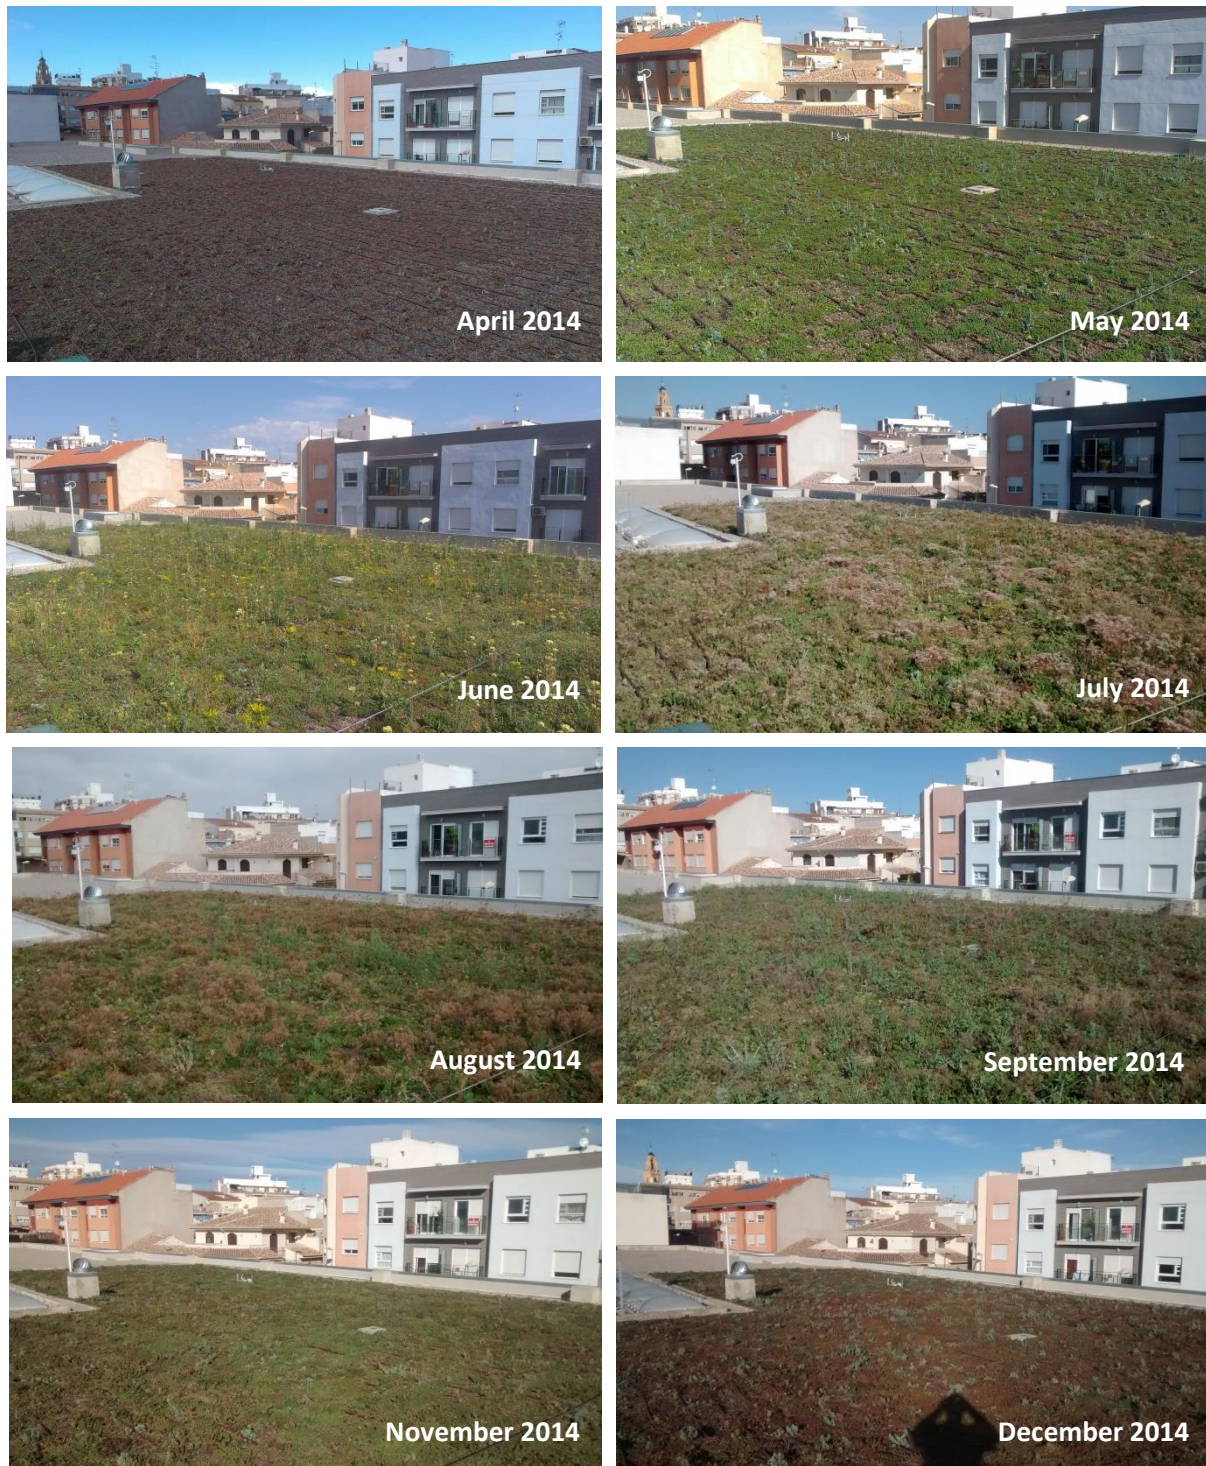
In the following figures, it can be observed the time evolution of the green roof in Benaguasil during the monitoring period. The vegetation looks drier in winter and greener in spring and summer.

Figure 2.7. Time evolution of the green roof in Benaguasil in the monitoring period (1).

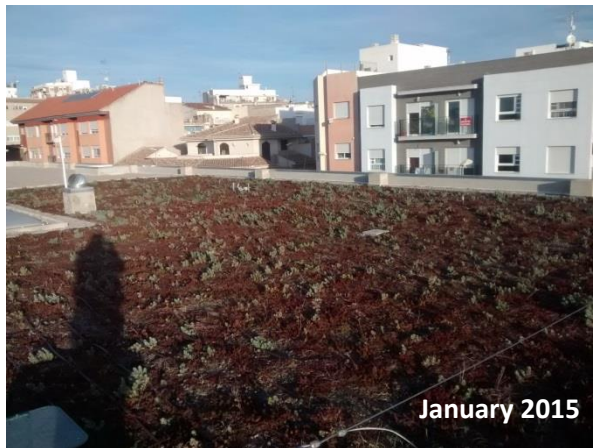
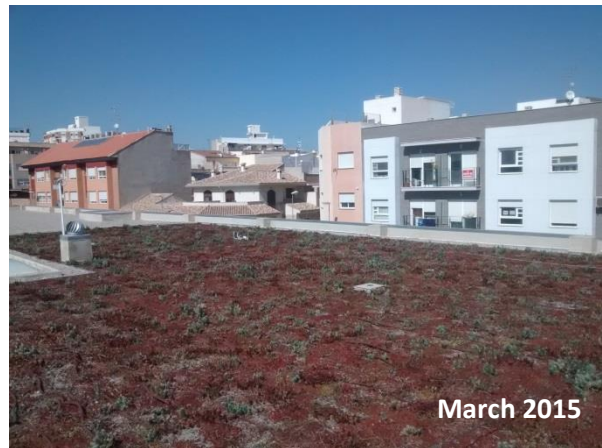
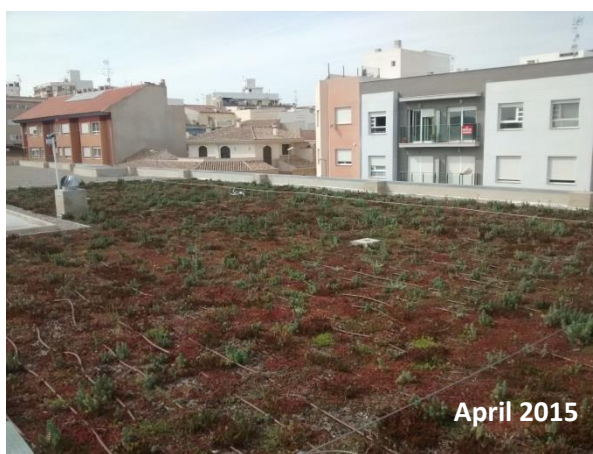
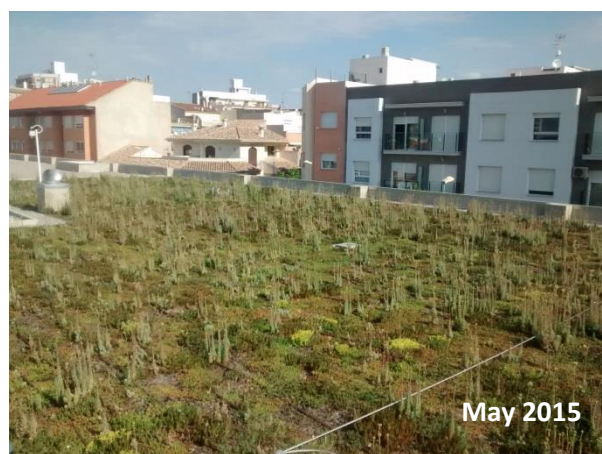
Figure 2.8. Time evolution of the green roof in Benaguasil in the monitoring period (2).

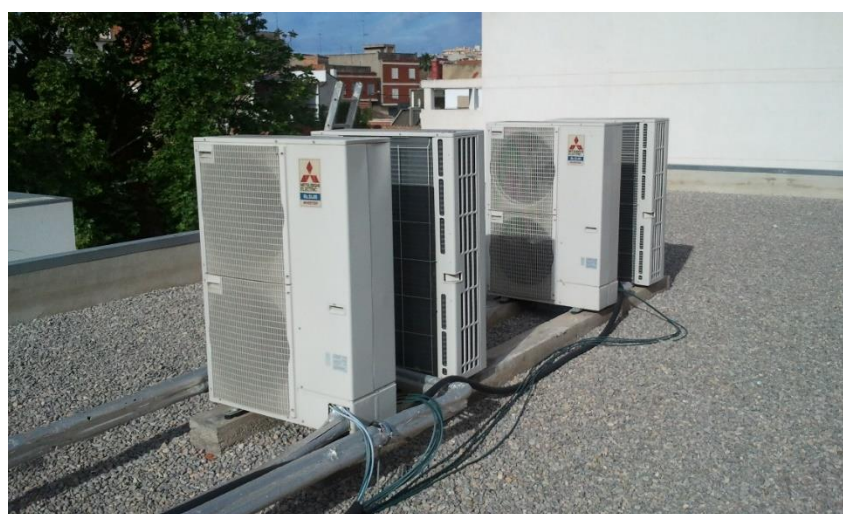
OUTDOOR UNIT: P250YHA

Figure 2.10. Air-conditioning outdoor unit.

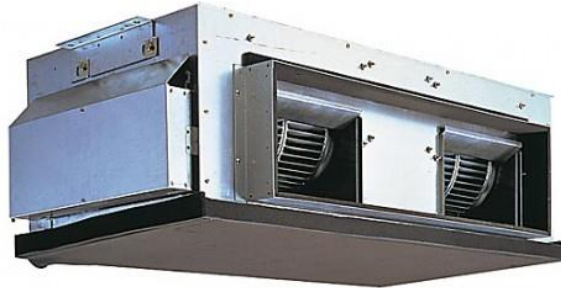
INDOOR UNIT: PEA-RP400GAQ / PEA-RP500GAQ

Figure 2.11. Air-conditioning indoor unit.

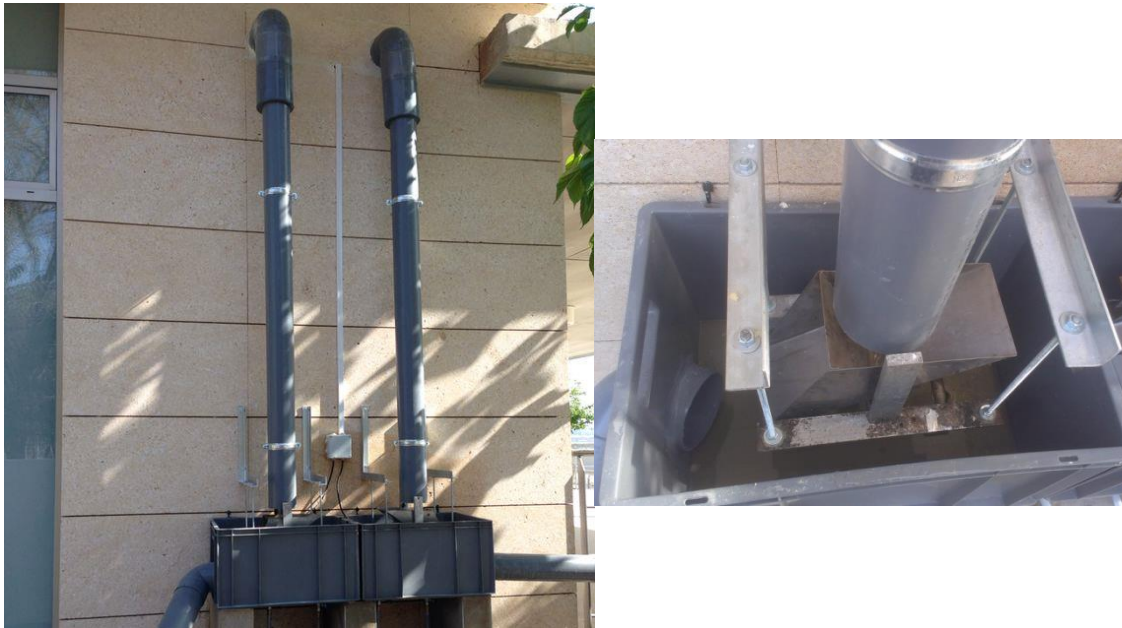
Figure 3.6. Tipping buckets to measure outflow rates from the conventional and the green roofs.

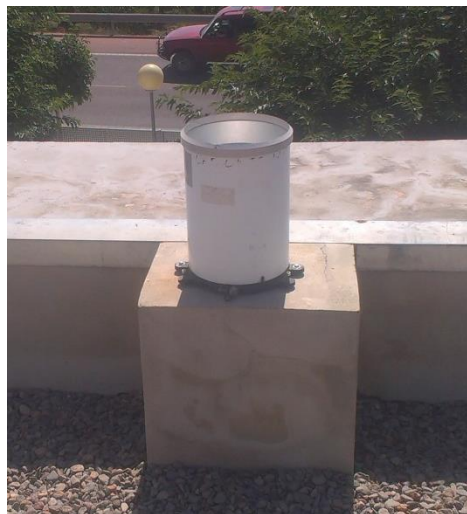
Figure 3.7. Rain gauge located in the green roof building.

Outflow rates from the roofs are compared with the rainfall data measured with a rain gauge located in the building roof (Figure 3.7).

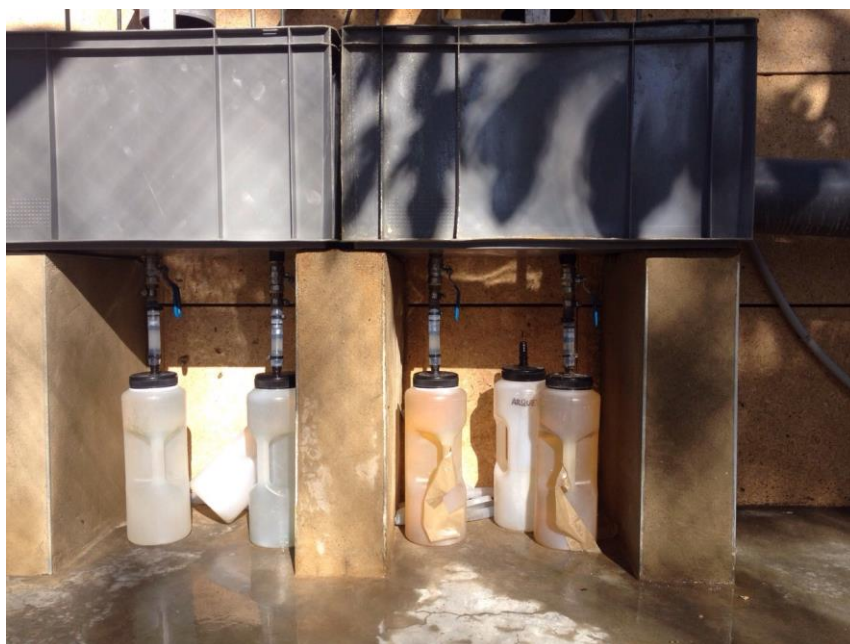
Water quality samples aim to compare the difference in the water quality processes between the green roof and its adjacent conventional roof. Samples were collected in four bottles linked to the tipping buckets (two bottles per tipping bucket). The boxes where the buckets were placed were designed to allow the bottles to be filled consecutively at the start of the rain event and thus, there were a total of four samples per event.

Figure 3.8. Outflows in the tipping buckets for the four water quality sampling bottles.

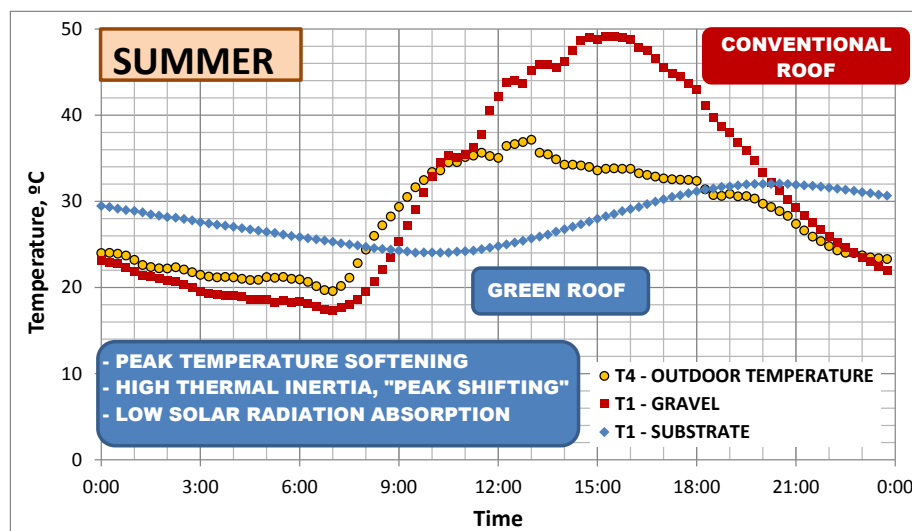
- Peak temperature is reached about 7-9 hours later than outdoor temperature.
- Peak temperature (below substrate) is 4-6 °C degrees lower than peak outdoor temperature.

An example of these thermal behaviour conclusions is included in Figure 4.1.

Figure 4.1. Comparative temperature profiles for summer.

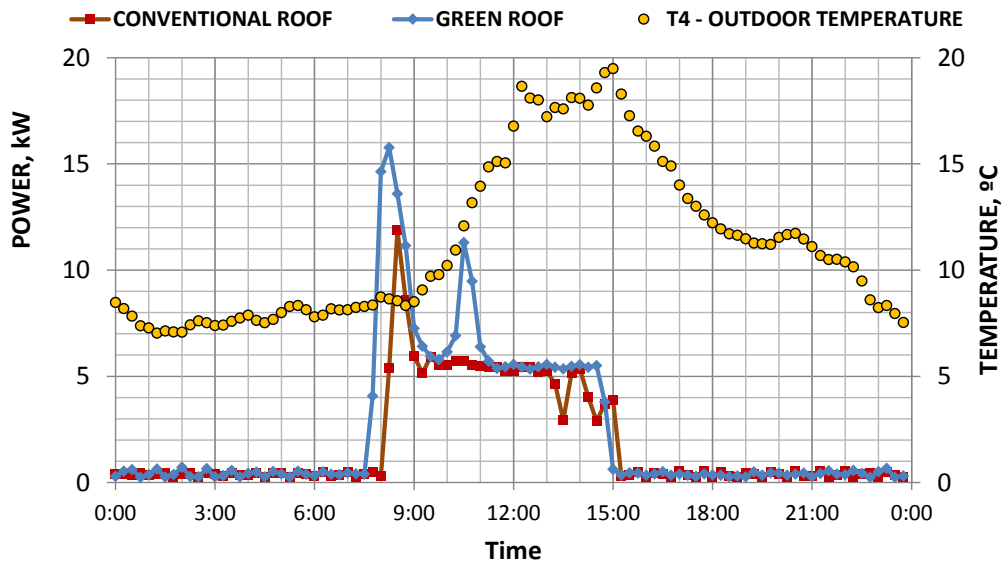
Figure 4.3 and 4.4 include real data of power consumption in summer and winter, respectively. It is observed, as expected, 25-30% of power savings for summer and slightly higher power consumption for winter.

Figure 4.4. Comparative power consumption profiles for winter.

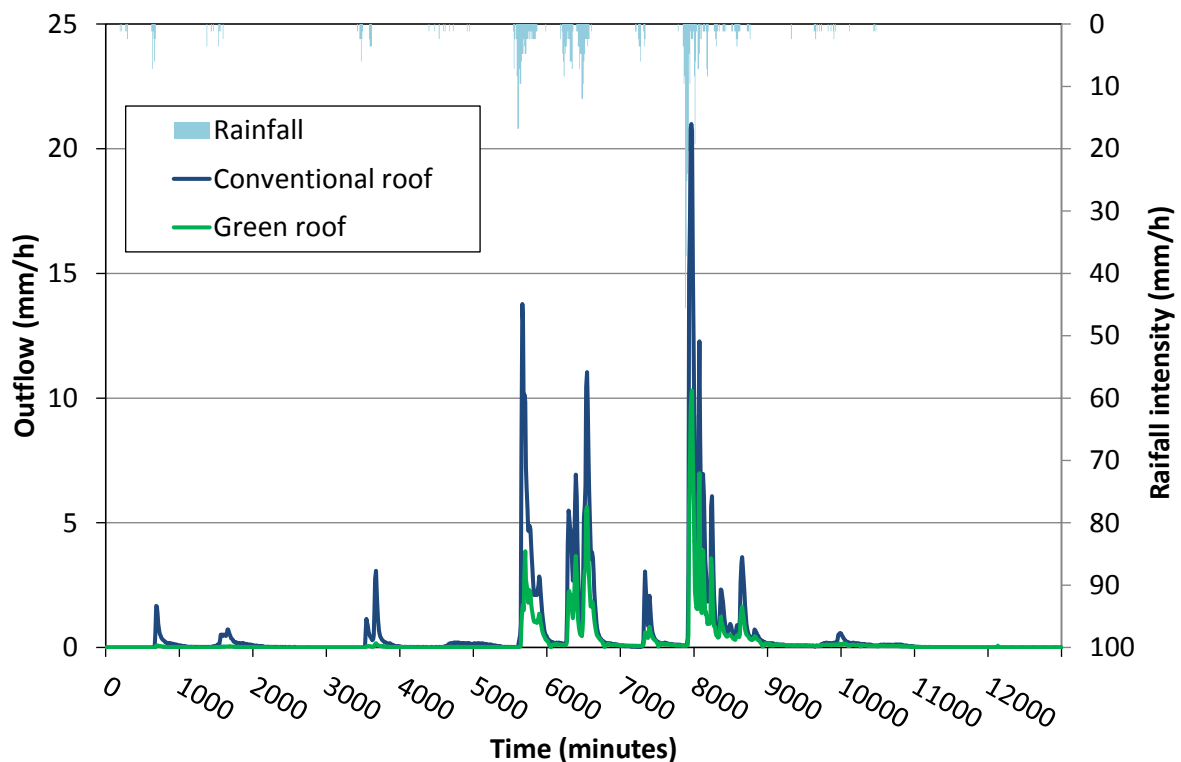
The most significant event began on 18/03/2015, with a total precipitation of 125.2 mm during four days. The performance of both roofs during this event is shown in the following figure:

Figure 4.5. Performance of the two roofs during the rainfall event that started on 18/3/2015.

Results show that the peaks of the outflow from the green roof are lower in all the cases, especially for lower intensity periods. If we focus on the highest intensity part of this rainfall event (Figure 4.6), this difference can be observed more clearly.

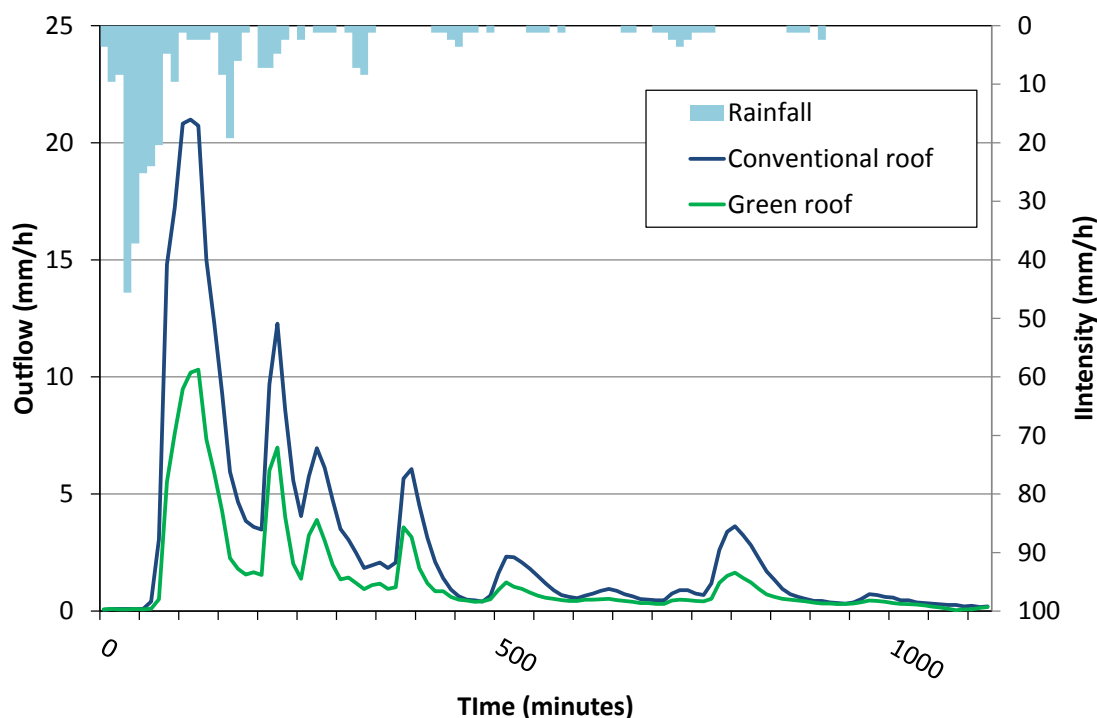
Figure 4.6. Performance of the two roofs during the highest intensity part of the rainfall event that started on 18/3/2015.

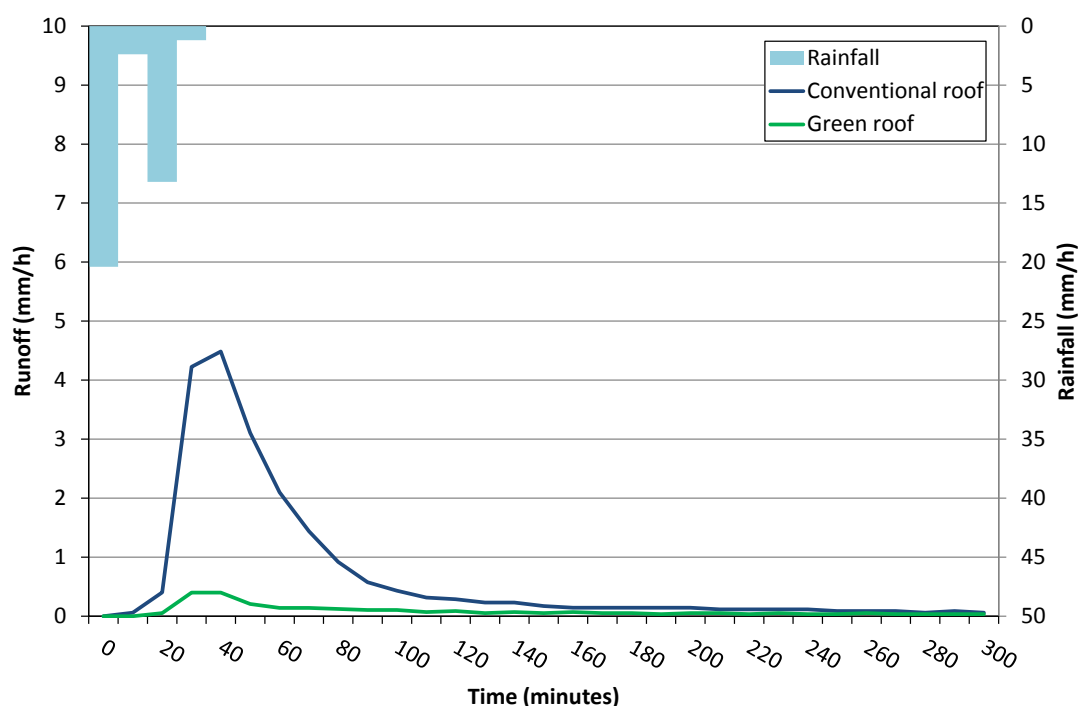
This reduction of runoff peaks and volumes is especially significant during low intensity events. For instance, in the following hydrograph the performance of the two roofs during the 12/10/2014 event is shown in Figure 4.7. As it can be observed, the runoff reduction in the green roof is significant, being about 88% of the total rainfall volume.

Figure 4.7. Performance of the two roofs during the event that started on 12/10/2014.
